Jim Moore Road-Sharon Church 230 kV Transmission Line and Flanagan Mill Road Advanced Land Purchase Substation Site Gwinnett and Barrow Counties, Georgia

Representative Photographs of Jurisdictional Streams

Results of the Environmental Justice Survey Jim Moore Road-Sharon Church 230 kV Transmission Line

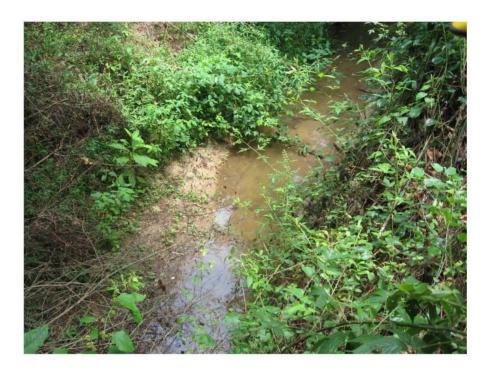
Lower Perennial Stream

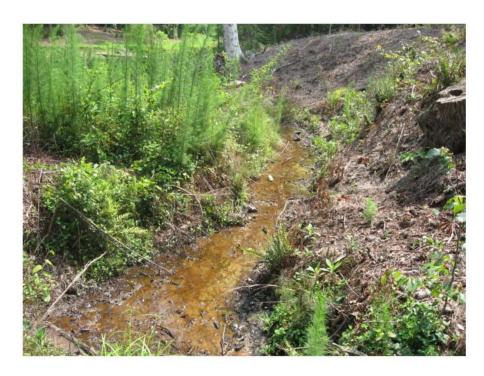
Intermittent Stream
